dsPIC33EPXXGS202 Family Silicon Errata and Data Sheet Clarification

The dsPIC33EPXXGS202 family devices that you have received conform functionally to the current Device Data Sheet (DS70005208C), except for the anomalies described in this document.

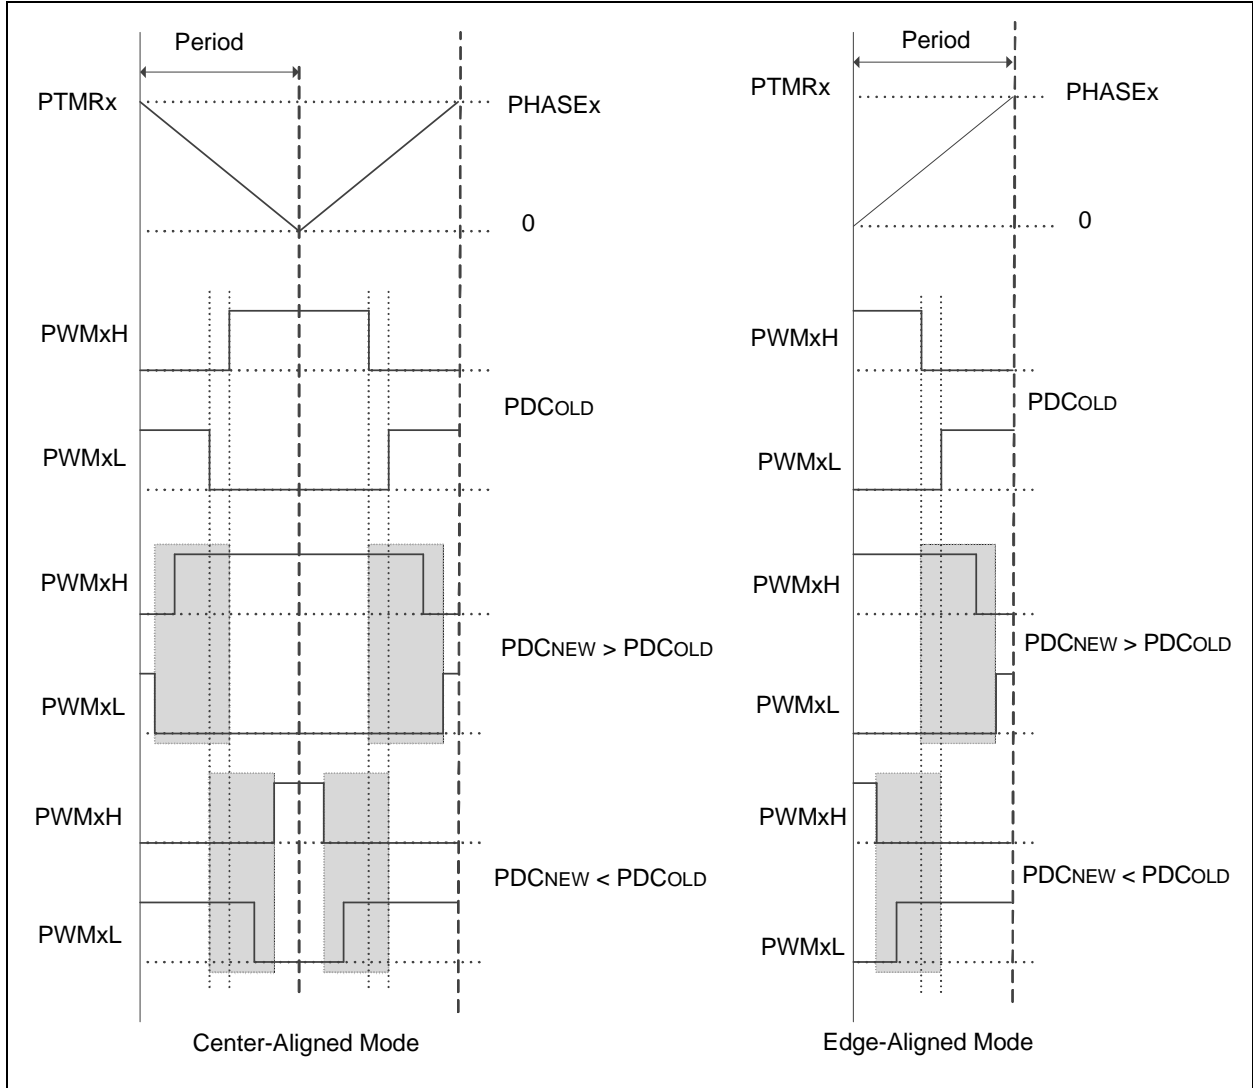
FIGURE 1: TIMING DIAGRAMS FOR CENTER-ALIGNED AND EDGE-ALIGNED MODES

The PWMx generator may not assert dead time on the edges of transitions. This has been observed when all of the following conditions are present:

- The PWMx generator is configured to operate in Complementary mode with the independent time base or master time base
- Immediate update is enabled
- The value in the PDCx register is updated in such a manner that the PWMxH and PWMxL outputs make an immediate transition

The current duty cycle, PDCOLD, newly calculated duty cycle, PDCNEW, and the point at which the write to the Duty Cycle register occurs within the PWMx time base, will determine if the PWMxH and PWMxL outputs make an immediate transition. PWMxH and PWMxL outputs make an immediate transition if the Duty Cycle register is written with a new value, PDCNEW, at a point of time when the PWMx time base is counting a value that is in between PDCNEW and PDCOLD. Additionally, writing to the Duty Cycle register close to the instant of time where dead time is being applied may result in reduced dead time, effective on the PWMxH and PWMxL transition edges.

In [Figure 1](#), if the duty cycle write occurred in the shaded box, then PWMxH and PWMxL will make an immediate transition without dead time.

None. However, in most applications, the duty cycle update timing can be controlled using the TRIGx trigger or Special Event Trigger to avoid the above mentioned conditions.

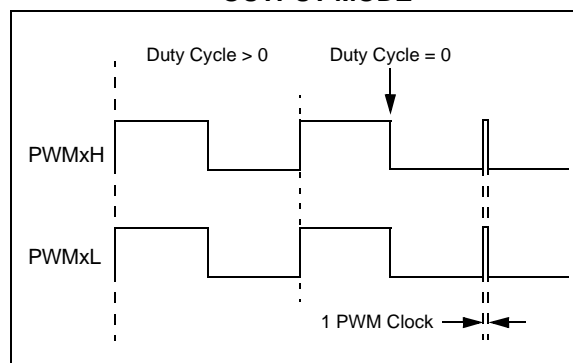
FIGURE 2: EXAMPLE FOR REDUNDANT OUTPUT MODE

In the Redundant Output mode (IOCONx<11:10> = 0b01) and Push-Pull Output mode (IOCONx<11:10> = 0b10), with the Immediate Update Enable bit disabled (PWMCONx<0> = 0), when the Duty Cycle register is updated from a non-zero value to zero, a glitch pulse of a width equal to 1 PWM clock will appear at the next PWM period boundary, as shown in Figure 2 (for the Redundant Output mode). The Duty Cycle register refers to the PDCx register if PWMCONx<8> = 0 or the MDC register if PWMCONx<8> = 1.

If the application requires a zero duty cycle output, there are two possible work around methods:

1. Use the PWM override feature to override the PWM output to a low state instead of writing to the Duty Cycle register. In order to switch back to a non-zero duty cycle output, turn off the PWM override. The override-on and override-off events must be timed close to the PWM period boundary if the IOCONx register has been configured with IOCONx<0> = 0 (i.e., output overrides through the OVDDAT<1:0> bits occur on the next CPU clock boundary).
2. Enable the Immediate Update Enable bit (PWMCONx<0> = 1) while configuring the PWMx module (i.e., before enabling the PWMx module, PTCON<15> = 1). With the Immediate Update enabled, writes to the Duty Cycle register can have an immediate effect on the PWM output. Therefore, the duty cycle write operations must be timed close to the PWM period boundary in order to avoid distortions in the PWM output.

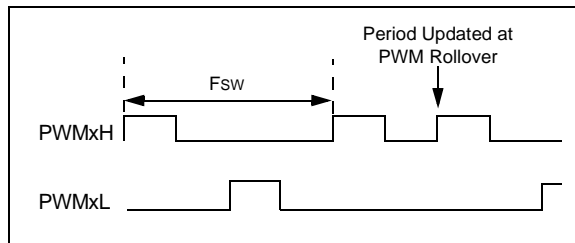
FIGURE 3:

When the PWM module is configured for Push-Pull mode (IOCONx<11:10> = 0b10) with the Enable Immediate Period Update bit enabled (PTCON<10> = 1), a write to the Period register that coincides with the period rollover event may cause the push-pull output logic to produce back-to-back pulses on the PWMx pins (Figure 3).

If the EIPU bit is set (PTCON<10> = 1), ensure that the update to the PWM Period register occurs away from the PWM rollover event. Use either the PWM Special Event Trigger (SEVTCMP) or the PWM Primary Trigger (TRIGx) to generate a PWM Interrupt Service Routine (ISR) near the start of the PWM cycle. The PWM Period register could be updated inside this ISR so that the period writes do not occur near the PWM period rollover event.

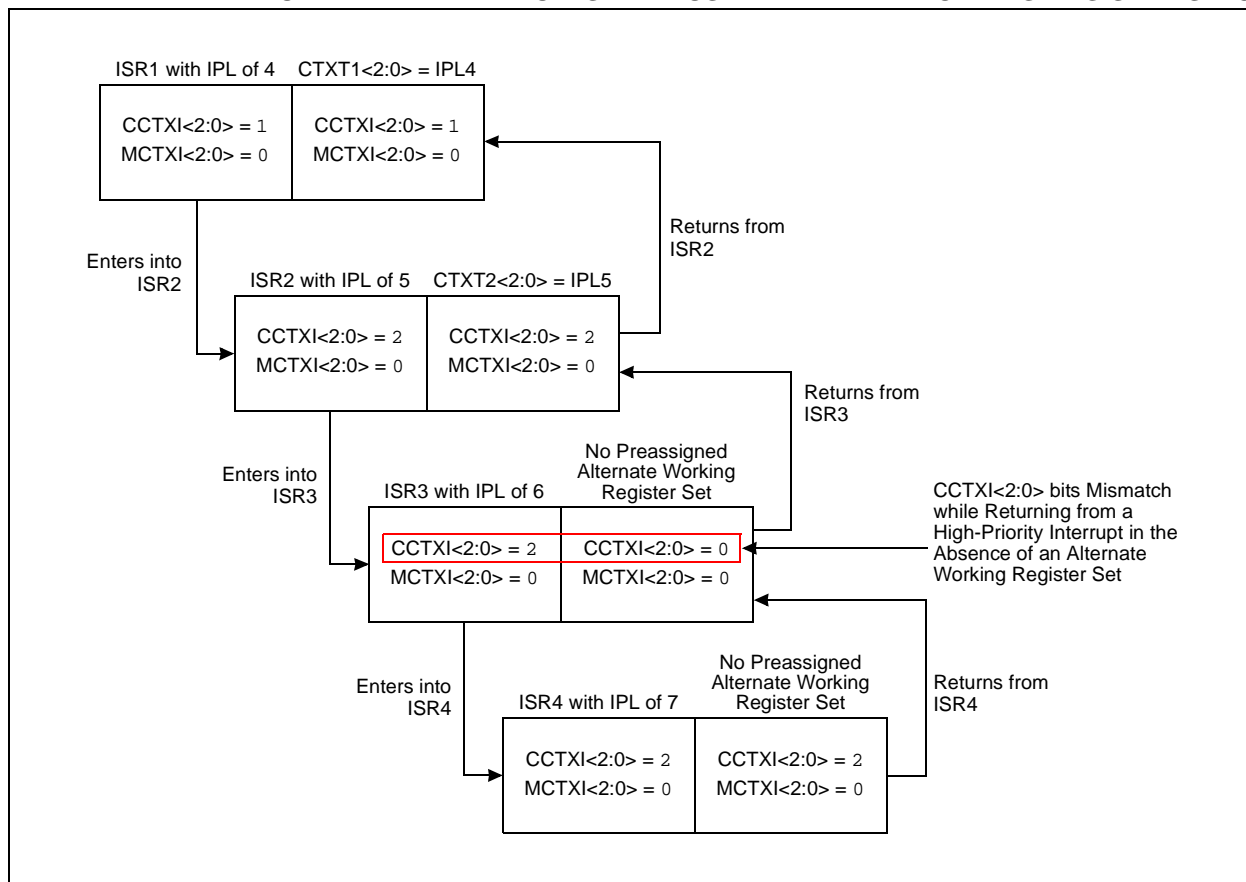
FIGURE 4: MISMATCH OF WORKING REGISTER SET WHEN NESTING MORE THAN ONE INTERRUPT WITHIN INTERRUPTS THAT USE ALTERNATE WORKING REGISTER SETS

When returning from an Interrupt Service Routine (ISR) by executing the `RETFIE` instruction, in the case of a nested interrupt, the Interrupt Priority bits (`IPC<3:0>`) associated with the lower priority interrupt are compared with the `CTXTn` bits field in the `FLTREG` Configuration register:

- If there is a match with either of the `CTXTn` bits field, then the corresponding Alternate Working Register Set is chosen and the Current Context Identifier bits (`CCTXI<2:0>`) in the `CTXTSTAT` register are updated to reflect the new Alternate Working Register Set.
- If there is no match with either of the `CTXTn` bits field, then the expected behavior is to keep the context (defined by the value of the Current Context Identifier bits, `CCTXI<2:0>` in the `CTXTSTAT` register) unchanged. However, the

context gets changed. A new context corresponding to the value in the Manual Context Identifier bits (`MCTXI<2:0>`) in the `CTXTSTAT` register is selected by the hardware and the `CCTXI<2:0>` bits in the `CTXTSTAT` register are modified to reflect this change.

When using interrupts with the Alternate Working Register Set (automatic context assignment), no more than one ISR without an Alternate Working Register Set must be nested within an ISR with an Alternate Working Register Set.

Issue and work around are illustrated in [Figure 4](#) and [Figure 5](#), respectively. The figures show the status bits, `CCTXI<2:0>` and `MCTXI<2:0>`, after entering into an ISR from a lower priority ISR (left pane), and after returning to the same ISR from a higher priority ISR (right pane).
